**TANK CONTAINER  
ON HIRE/CONDITION  
INSPECTION REPORT**

CONTAINER NUMBER <i>10TU 240407-6</i>		CUSTOMER <i>TANKSPAN</i>		SURVEY DATE <i>30.6.01</i>	LOCATION <i>Felixpolys, HAP</i>	DEPOT
TANK TYPE <i>1 No.1</i>	MANUFACTURER <i>CIEA/NEW</i>	BUILT <i>7/2000</i>	CSC DUE DATE <i>7/0005</i>	MAX GROSS WT <i>36000 Kgs.</i>	TARE WT <i>3980 . Kgs.</i>	
TANK CAPAC. <i>24000 Ltrs.</i>	LAST TESTS/AUTHORITY <i>2 1/2 Yrs: / 5 Yrs: 7/2000</i>		RELEASE NR. <i>RL 1971954</i>	EIR NR.	REPORT NUMBER

# INTERNAL INSPECTION REPORT

TANK SERIAL NO. TASU.240407-6 LAST PRODUCT: Wine  
 Location: H.P. Felixsoode Ref. No. RL/971984  
 Inspected By: BARRY TITE Order No.  
 Date: 30.6.01

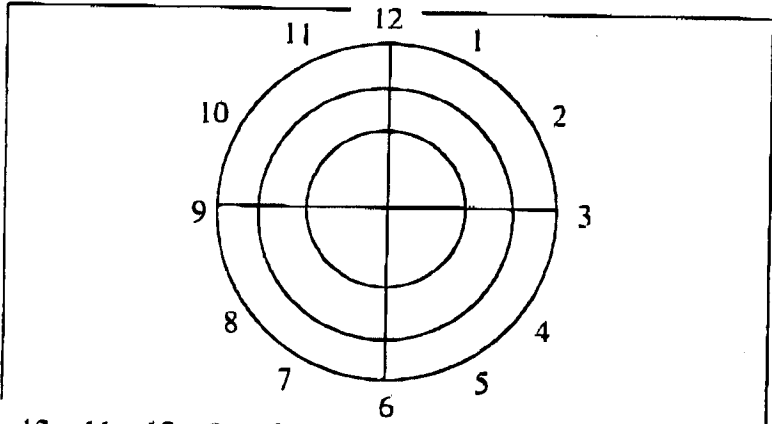
## FRONT

*No Remarks*
