ON HIRE/CONDITION INSPECTION REPORT

INTERNAL INSPECTION REPORT

TANK CONTAINER INSPECTION REPORT

TANK NUMBER : Gasn. 111010.3

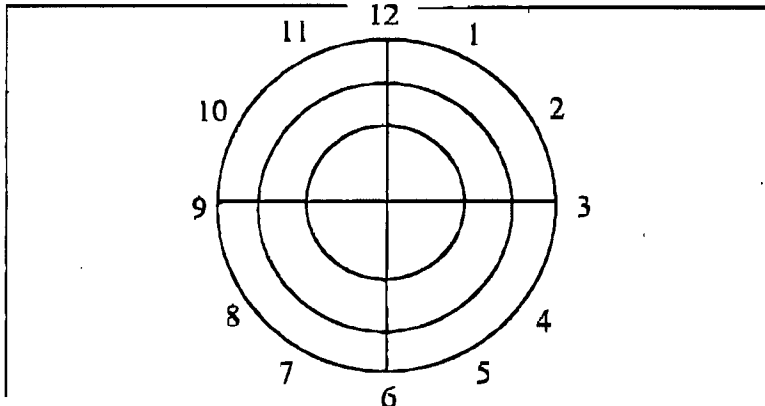
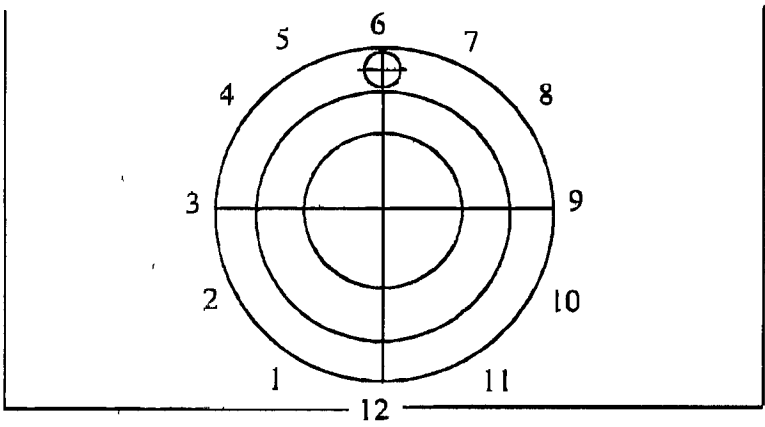
To wipe out
clear

Air Line Valve/Gasket/Gauge	✓		MFR _____ Range _____
Top Disch. Prot. Cover/Spillb.	✓		
Top Disch. Valve		✓	MFR _____ Butterfly/Ball
Top Disch. Blank/Gas.	✓		
Top Operated Int. Footvalve		✓	
Tir strips bottom/top	✓		
INTERNAL CONDITION			
Cleaned / Dry	✓		<u>Ins to wipe out</u>
Discoloured		✓	<u>see mapping</u>
Rusted		✓	
Corroded		✓	
Pitted/Lamination Pitting		✓	
Thermometer probe		✓	
Valv. Clean fr. Moist/Res.	✓		
Siphon tube		✓	
Footvalve	✓		
Bursting discs		✓	MFR _____ Range _____
Cleanliness certificate	✓

REMARKS : Inside to wipe out
